CITY OF BALTIMORE WET W SMOKE AND DYED W	Page 1 of 5	
Sewershed: JONES FALLS	Company: REI/DRAYCO	Date: 07/08/08
Test to be Performed: SMOKE	Ground Condition: DRY	Supervisor: ER
Manhole ID: S39OO_014MH	Test ID: 0994-357	Notifications Made:_X (Residents, Fire, 311)

CITY OF BALTIMORE SMOKE TESTING OBSERVATION SUMMARY JONES FALLS SEWERSHED

BALTIMORE CITY PROJECT 994 REI/DRAYCO

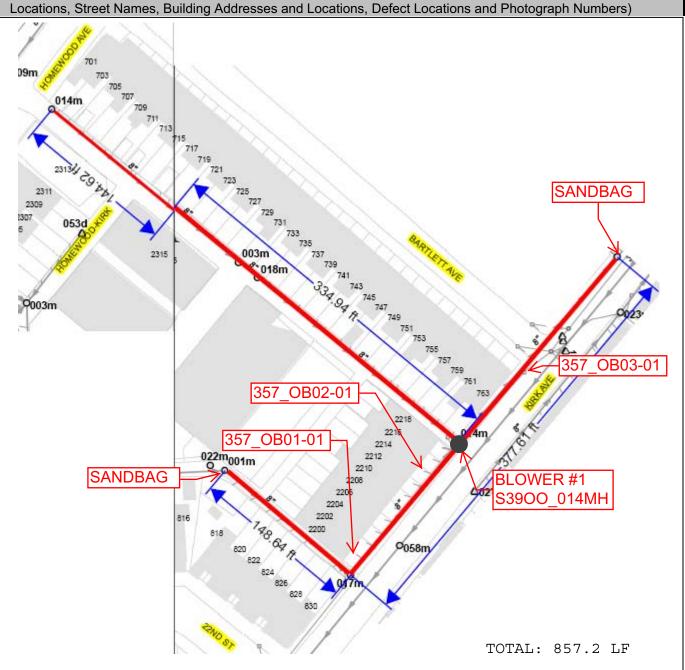
Field Sketch: (Show All Manholes with Numbers, Blower Placement Location, Sandbag or Isolation Locations, Street Names, Building Addresses and Locations, Defect Locations and Photograph Numbers)

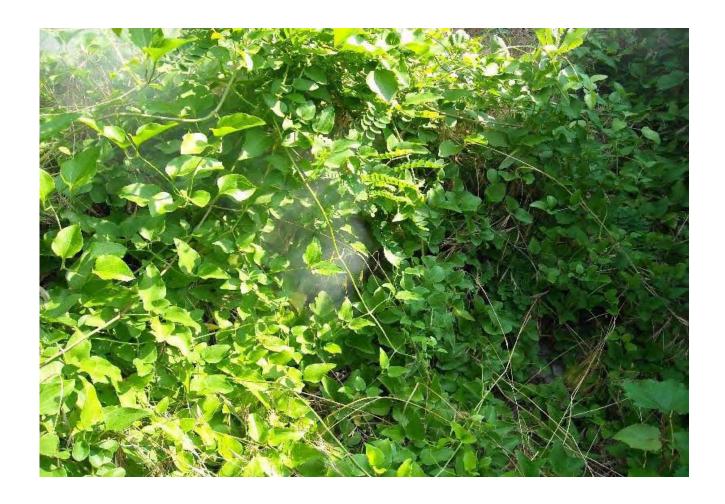
Photograph No: OB01-01 Filename: 0994-357_OB01-01.jpg

Unique Test ID: 357	Date: 07/08/2008	Basin: JF-19
Defect No: OB01	Supervisor: E.R.	Dye Test Recommended: N
House No: 2200	Street Name: KIRK	Street Type: AVE.
Source Type: 03	Location: 07	Severity: 03
Sector: 02	Drainage Area: 3

Comments: CLEAN OUT - AT GRADE - BROKEN CAP

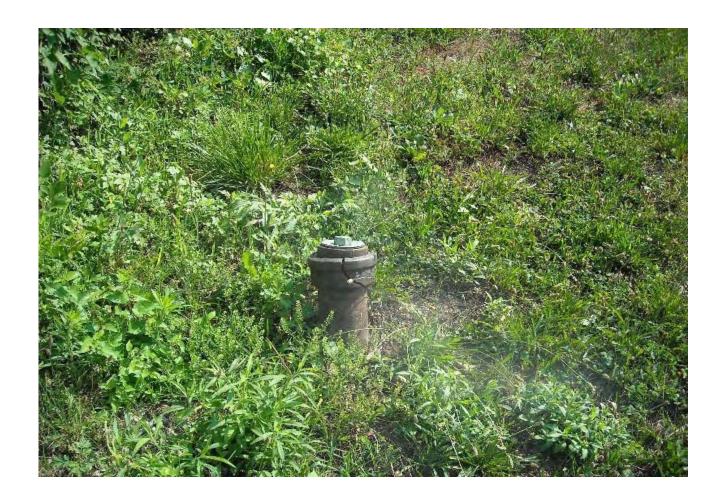
Photograph No: OB02-01 Filename: 0994-357_OB02-01.jpg

Unique Test ID: 357	Date: 07/08/2008	Basin: JF-19
Defect No: OB02	Supervisor: E.R.	Dye Test Recommended: N
House No: 2214	Street Name: KIRK	Street Type: AVE.
Source Type: 03	Location: 07	Severity: 02
Sector: 02	Drainage Area: 3

Comments: CLEAN OUT - ABOVE GRADE - BROKEN CAP

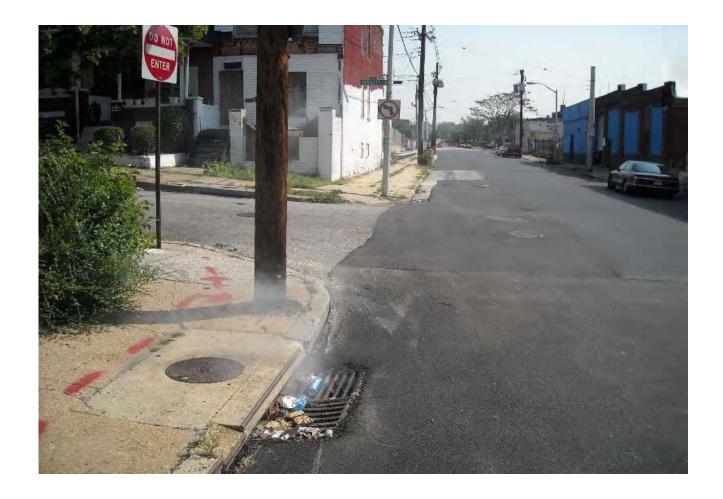
Photograph No: OB03-01 Filename: 0994-357_OB03-01.jpg

Unique Test ID: 357	Date: 07/08/2008	Basin: JF-19
Defect No: OB03	Supervisor: E.R.	Dye Test Recommended: N
House No: 783	Street Name: BARTLETT	Street Type: AVE.
Source Type: 11	Location: 02	Severity: 03
Sector: 01	Drainage Area: 2000

Comments: SMOKE COMING OUT OF STORM DRAIN AT KIRK AVE. & BARTLETT AVE.
